Section: <b>01</b>	Date: <b>2017-10-23</b>	Job ID: <b>1234-5678</b>	Client: <b>MINICAM</b>	Operator: <b>M.STARK</b>
-----------------------	----------------------------	-----------------------------	---------------------------	-----------------------------

Place: <b>GOLBORNE</b>	Direction: <b>Upstream</b>	Start Ref: <b>0401</b>
Road: <b>MARYFIELD CLOSE</b>	Use: <b>Combined</b>	Start Depth: <b>1.12m</b>
	Pipe Shape: <b>Circular</b>	End Ref: <b>9402</b>
	Pipe Material: <b>Concrete</b>	End Depth: <b>1.09m</b>
	Width / Height: <b>300mm</b>

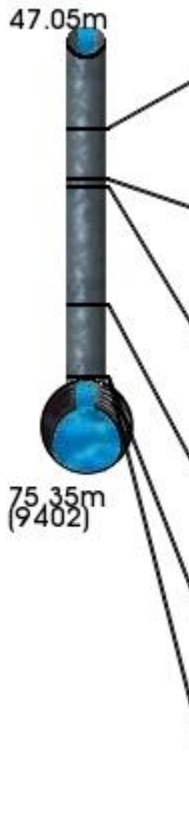
Meterage	CD	Code	Observation	Video	Pic.
64.38m		JNX	JNX: Junction Not defective 100 mm. At 10 O'Clock	00:07:31	
66.66m		ECX	ECX: Encrustation Light. from 12 O'Clock to 5 O'Clock	00:07:59	(2)
66.96m		JNX	JNX: Junction Not defective 100 mm. At 2 O'Clock	00:08:15	
72.23m	S1	ECX	ECX: Encrustation Light. from 5 O'Clock to 7 O'Clock S1	00:09:06	(3)
75.35m	F1	ECX	ECX: Encrustation Light. from 5 O'Clock to 7 O'Clock S1	00:10:08	
75.35m		ENX	ENX: End of survey.	00:10:11
